PCV-08F-08F-13-023-V

| <b>PCV</b> Pneumatic service check valve | | <b>Model Code</b> |

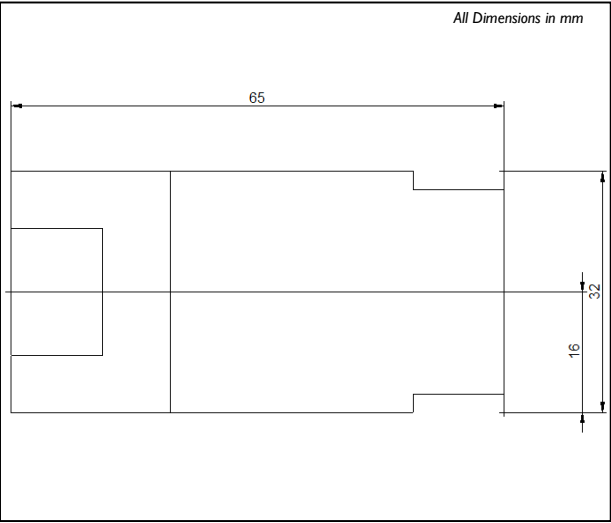
Dimensional Drawing

| <b>08F</b> | 1/2" NPT female | <b>Inlet Connection</b> |
| <b>08F</b> | 1/2" NPT female | <b>Outlet Connection</b> |
